# TOYO TIRE TALK

No.04-009 (TTT-166)

## Subject : Tyre Damage During Mounting

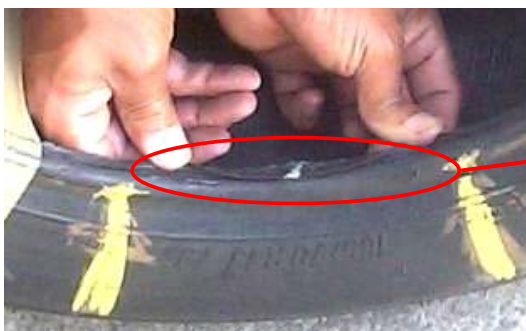
### Case 1 : Bead Base Damage

There is a cut on the bead base, which can reach the ply cord in extreme cases.

Injury by the mounting/demounting head of the fitting machine.

1) Ensure the head set is in the correct location.

2) Inspect for any bruise or deformation at the rim flange.

3) Lubricate properly.

4) Take extra care when installing LT tires with their wider bead base.

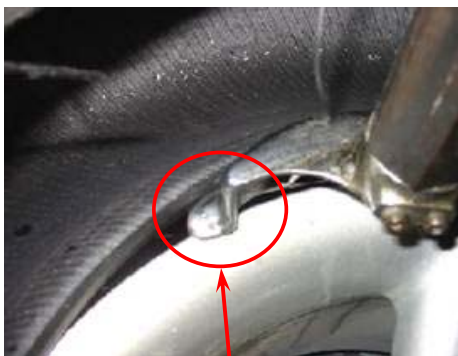
The mount/demount head injures the bead base.

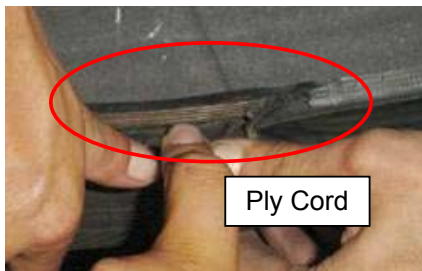
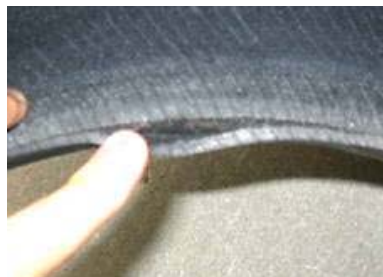
**Case 2 : Bead Toe Damage**

There is a circumferential cut on the inside of the tyre along the bead toe. The ply cord may be damaged if the cut is deep enough.

Use of a damaged or deformed rim.

- 1) Confirm that the rim flange is not damaged or deformed.
- 2) Ensure the correct lubrication type and quantity is used.

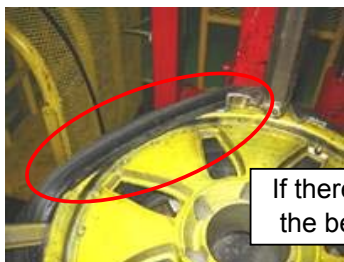
If there is a bruise or deformation in the flange, the bead toe may be injured during mounting.

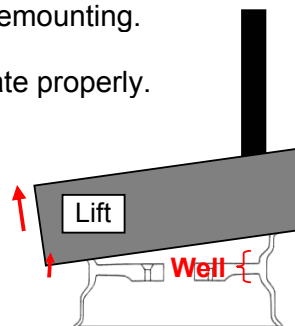
Lower bead toe is torn by the flange of the wheel during

- 1) Lift the lower bead of the tyre during demounting.
- 2) Lubricate properly.

Lift lower bead to upper wheel well.
