TOYO TIRE TALK

No. 02-010 (TTT-131)

Subject : Probable Cause for Vibration ... Tyre-Rim Slip

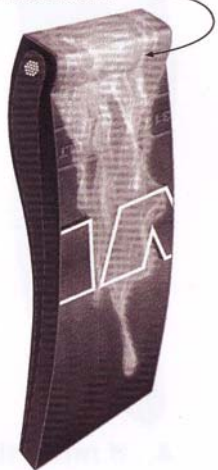
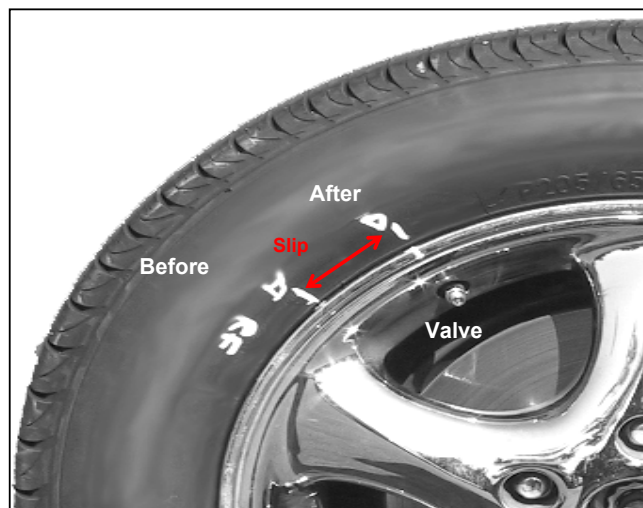
Example of Excessive Lubrication

Presently many tyre dealers are applying lubrication carelessly. Excessive lubrication can cause slip between the tyre and rim resulting in a vibration problem.

INCORRECT APPLICATION
 OF LUBRICANT

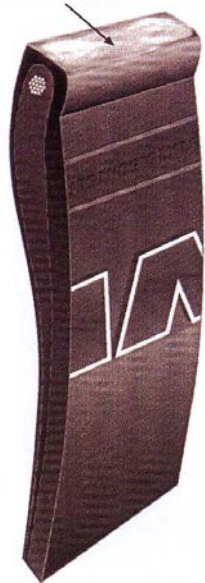
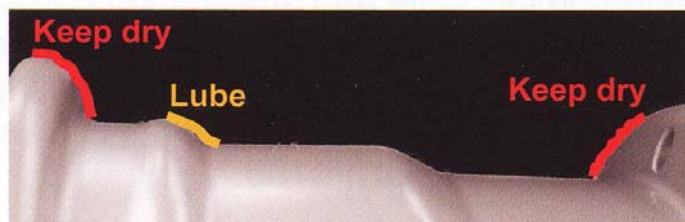
1. For new tyre and wheel assemblies, clean any manufacturing related lubricants from the tyre beads with an approved rubber cleaning fluid commonly used in the tyre repair processing.
2. Clean the wheel bead seating area.
3. Using a sponge and paste type lubricant, lubricate the tyre bead sole as shown in the photograph below.
4. If more than 40 psi is required to seat the beads, dismount the tyre, relubricate the tyre, and repeat the process.
5. Index the wheel valve stem to some location on the tyre sidewall, so that in the event of a customer returning for a vibration complaint, tyre-rim slippage can be determined.
6. In the event of a customer complaint where tyre-wheel slip has occurred, remove the old weights and rebalance the assembly. Do not dismount the tyre unless there is a requirement to match-mount the assembly.

High performance, low profile passenger tyres mounted on European made alloy wheels may require higher mounting pressures as bead seat tolerances may be tighter. Additional lubrication of the safety hump may be required to facilitate bead seating (see below).

CORRECT APPLICATION
OF LUBRICANT
